SAWYER LAKE DAM STATUS UPDATE &

NEXT STEPS

Meeting with the Sawyer Lake Village District

January 20, 2022

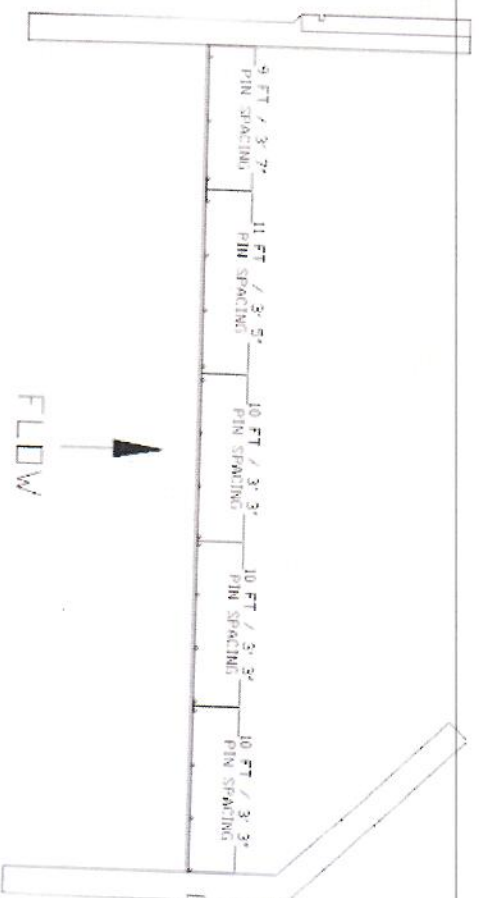
Findings to Date: Existing Pin spacing found to not match Dam Bureau As-built/Design Drawings.

Figure 1 - pins spacing as found by QCC in As-Built Drawings, 1-1/4" diam. steel pipe pins, with 3'-3" high flashboards

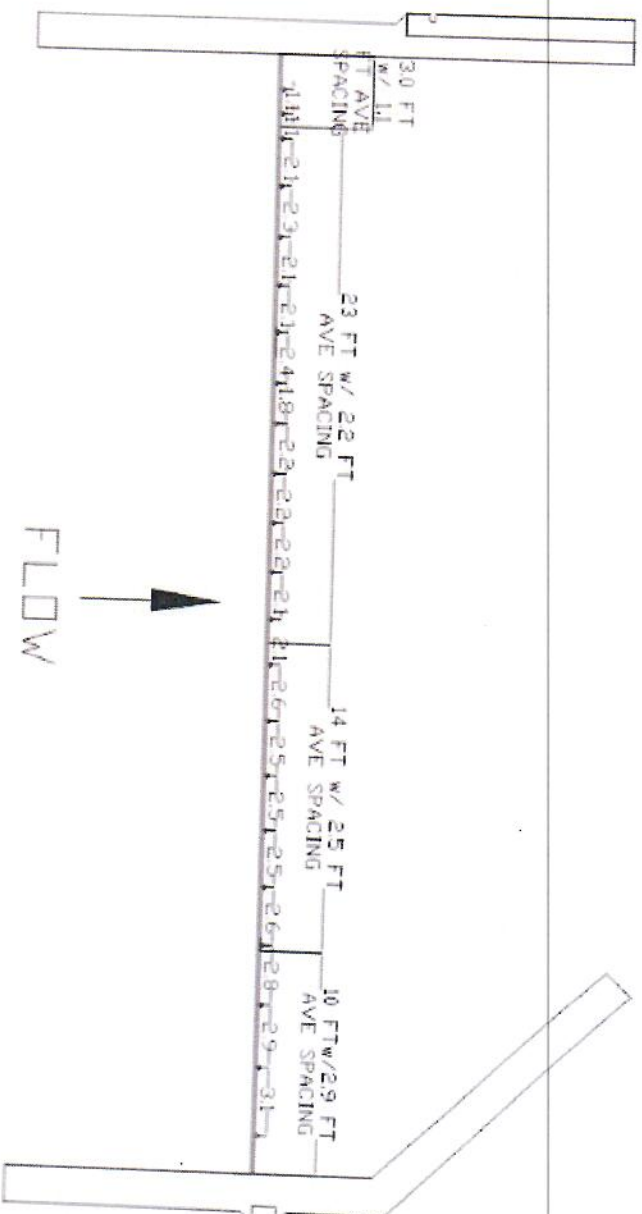
Figure 2 - pin spacing as measured March 20, 2021, 1-1/4" steel pipe pins, with 32 1/2" high boards

Findings to Date: Different pin spacing means boards will not fail as intended, which changes dam discharge capacity.
